## Federal Creosote Superfund Site OU1 Phase 1 – Lagoon B Remedial Action Report July 2005

## **OU1 PHASE 1 REMEDIAL ACTION FEDERAL CREOSOTE SUPERFUND SITE MANVILLE, NEW JERSEY**

**July 2005**

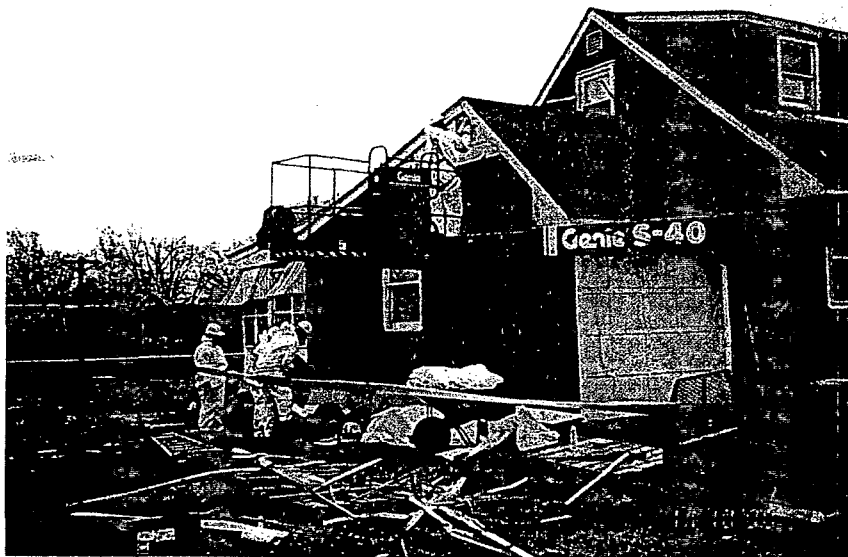
Photo 3-1 – ACM Shingle Removal

Subsequent to the confirmatory sampling and prior to the demolition of the houses, CAPE removed and disposed of all ACM. Removal activities were performed in accordance with all applicable Federal, State, and local regulations and the project specifications. A total of 120 CY of ACM including floor tiles, sheet vinyl, siding, etc. was removed from the site and disposed of at Waste Management Tullytown Resource Recovery Facility (TRRF) in Tullytown, PA. Copies of the waste manifests are included in Appendix B.

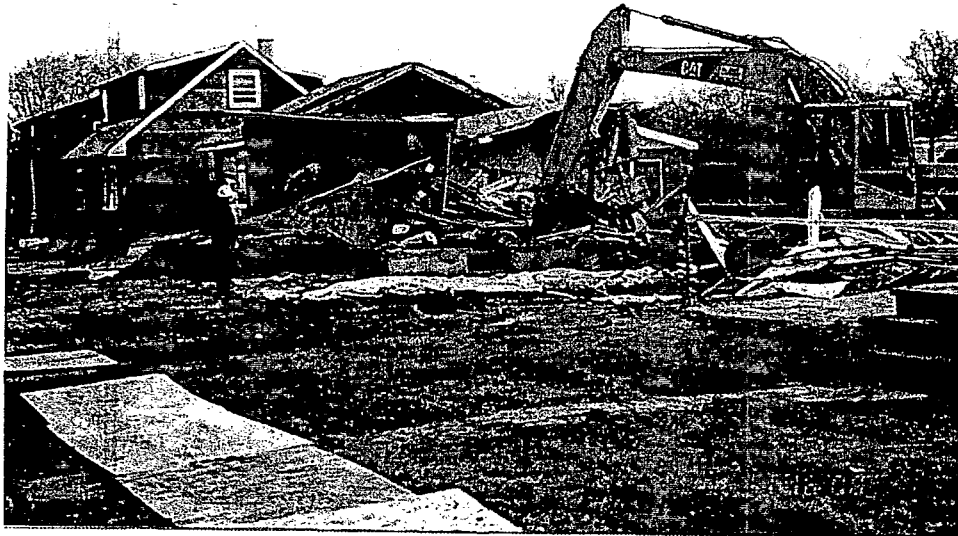
Photo 3-2 – Building Demolition

Because of the gap in time between the demolition and the remedial action, the basements of the demolished houses were filled with crushed stone to mitigate an open-hole hazard.

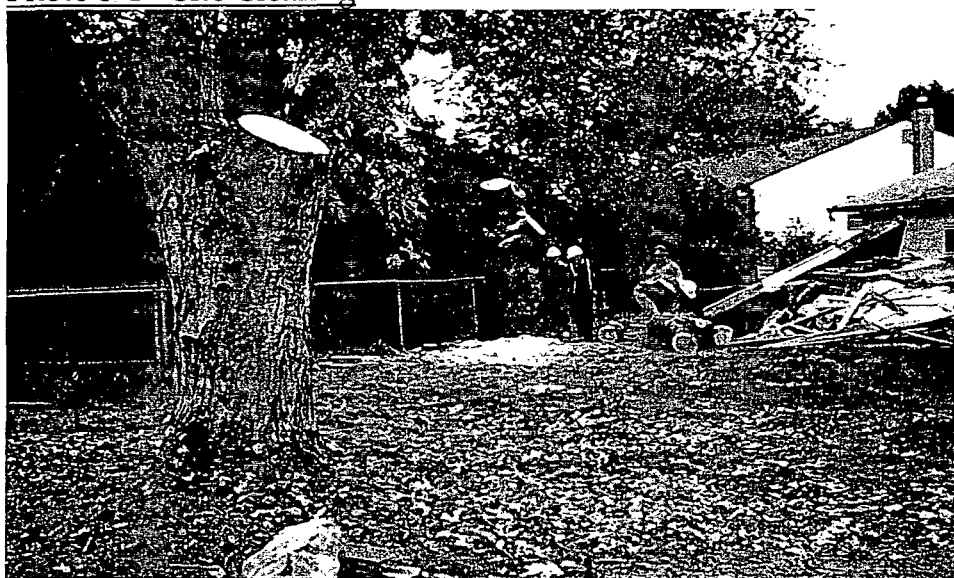
Photo 3-4 – Site Clearing

Trees, bushes, vegetative and ornamental plants within the Lagoon B properties were removed. All structures were also demolished during the demolition phase of the construction.

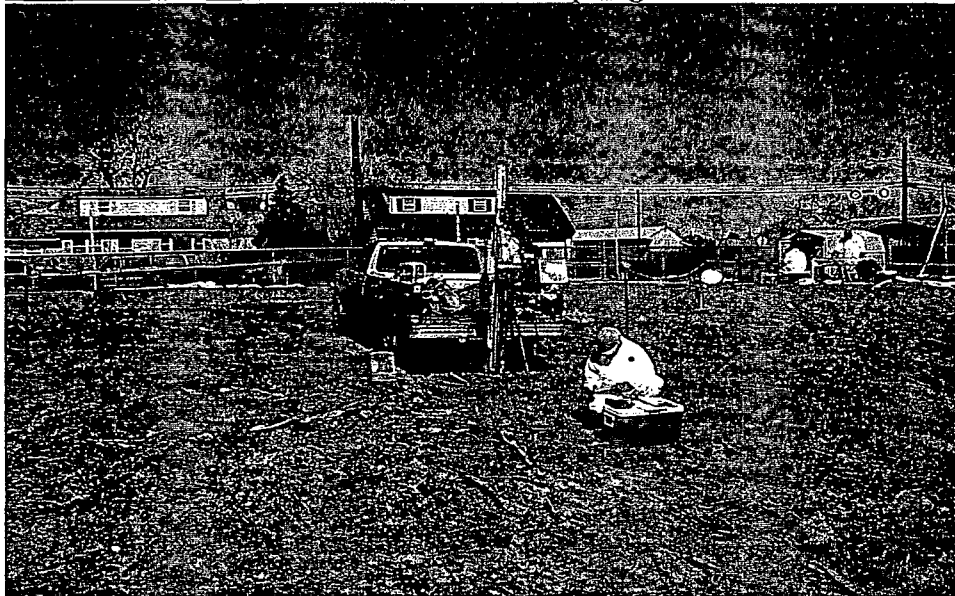
Photo 3-5 – Waste Characterization Sampling

The results of this sampling event were utilized to segregate excavated materials. Materials segregation was accomplished as described in Section 3.9.

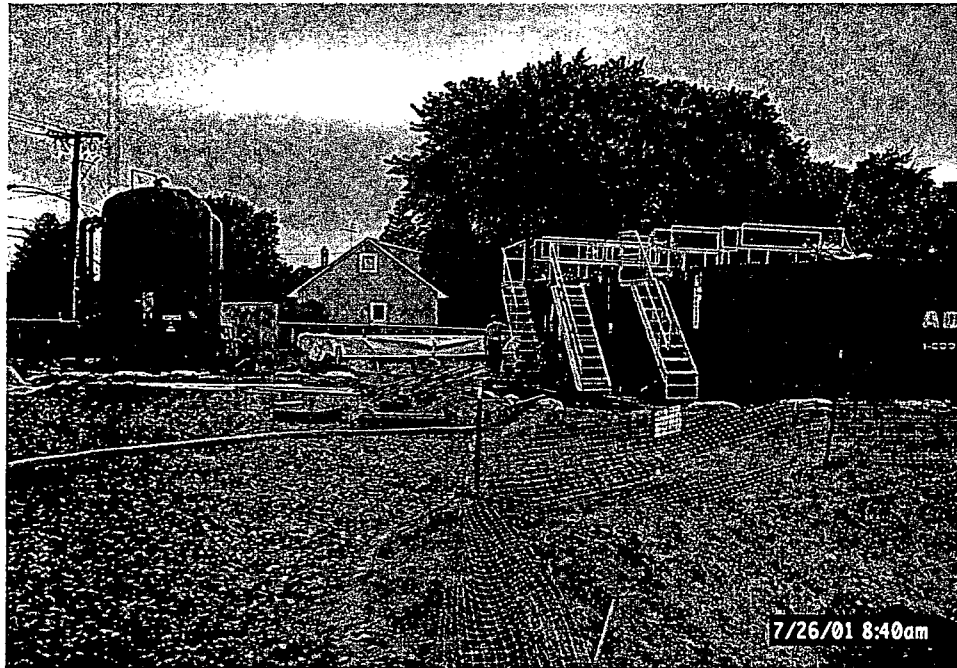
Photo 3-11 - WWTP under Construction

also included in the manual. SES obtained a permit in EPA's name (Permit No. 01-0568) from NJDEP to construct and operate the plant. A copy of the permit is included in Appendix G. A total of 33,837,458 gallons of water were treated and discharged during the Lagoon B remedial activities.

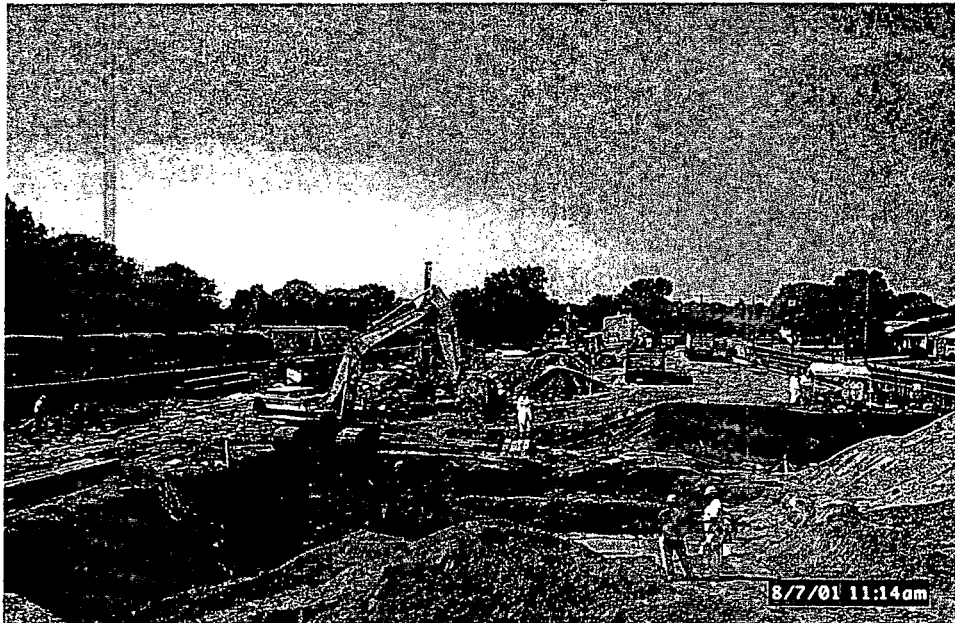
Photo 3-12 - Excavation and Backfill in Lagoon B

Excavated materials were segregated into three distinct stockpiles corresponding to the types of disposal as described in Section 3.9. To avoid cross contamination from one stockpile to another, SES designated an excavator for each stockpile. Typically a Komatsu PC300 was dedicated to the stockpiles designated as thermal treatment and Subtitle C, and a Komatsu PC200 was dedicated to the Subtitle D stockpile. Using the smaller excavator for Subtitle D enabled it to do other work around the excavation when it wasn't being used for loading. Stockpiled materials were loaded into lined trucks for transportation to treatment or disposal facilities.

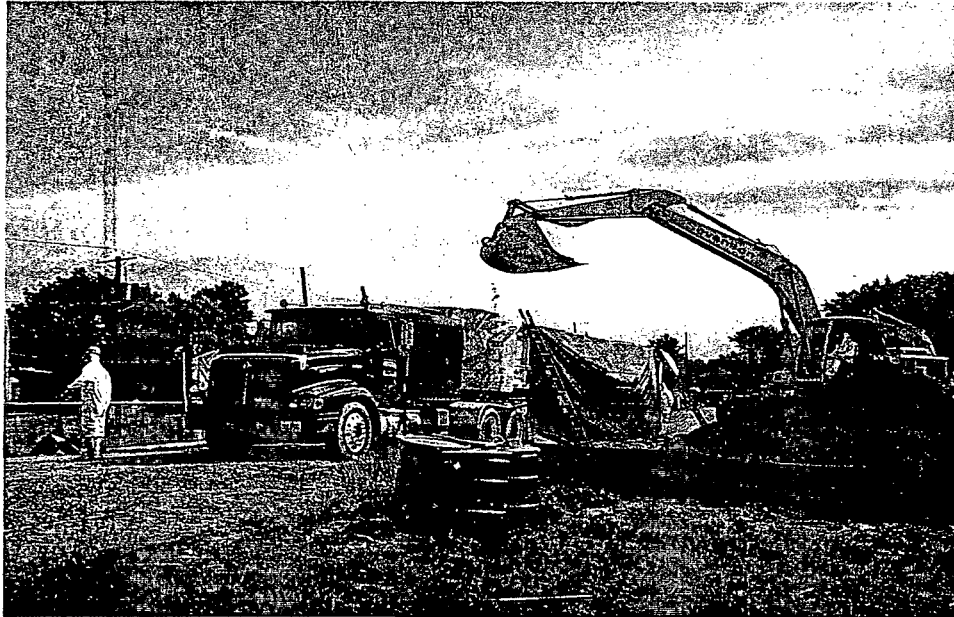
Photo 3-13 – Loading Material from Stockpile

trailers for transportation to the thermal treatment facility. All trucks transporting excavated materials to the facilities were required to be lined. Shipments of waste were routed to the main highways following haul routes in SES's approved transportation and disposal plan. Prior to leaving the site the trucks were decontaminated, weighed, and manifested.
